REPORT ON THE LOSS OF VIKRAM LANDER OF CHANDRAYAAN 2 MISSION

Malaya Kumar Biswal M¹, Ramesh Naidu Annavarapu²

Department of Physics, Pondicherry University, Puducherry – 605 014, India.

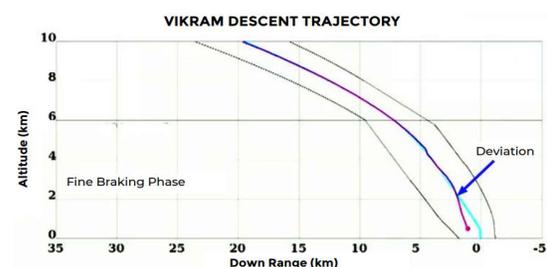
Trajectory Deviation: From the trajectory map of Vikram lander operation, we can see that the lander trajectory path was normal up to 2.2 km, but at an altitude of 2.1 km the lander’s trajectory got deviated from usual path resulting in the loss of communication

and uncertain mission status. Observed trajectory deviation is from 2.1-0.2 km above the lunar surface. The deviated trajectory path from 0.2-2.1 km is shown in Figure 2.

Figure 2 Vikram Lander Trajectory (Credit: ISRO)

- During the course of rough braking phase and powered descent phase, the vibrations aroused may have misplaced or unplugged the power cord of the communication system (or antenna) resulting in the loss of communication from the ground.
- At the point of deviation shown in the trajectory graph, the shutdown of thrusters or improper firing of descent thrusts

might have caused the spacecraft to lose control over spacecraft orientation resulting in the crash of lander on to the surface.

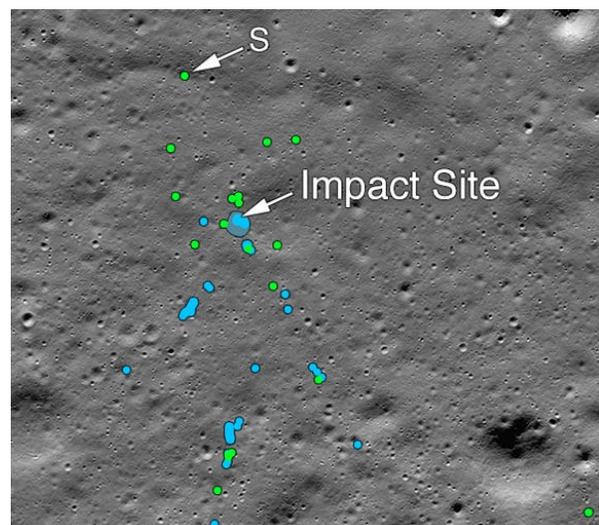
Mission Overview: The Chandrayaan 2 mission commenced on 22 July 2019 at 21:21 UTC with the launch of GSLV from SHAR. The orbiter along with lander Vikram approached Moon on 20 August 2019, then performing its 1st Lunar bound maneuver the spacecraft got successfully captured by the Moon orbit. Following successful orbital insertion, the spacecraft performed five additional lunar bound maneuver to initiate lander separation and lunar landing. The Vikram lander got separated from the main bus orbiter on 6 September 2019 at 20:08 UTC and progressed towards landing operation. Up to an altitude of >2.1 km from the lunar surface, all the mission parameters went normal, after attaining the altitude of 2.1 km, the lander unexpectedly lost communication from the ground at 20:23 UTC (15 minutes elapsed of landing phase initiation) resulting in failure of the lunar landing. The complete landing sequence of Vikram lander is shown in Figure 1. Following the search for impact site of lander, Shanmuga Subramanian the first to report the changes in activity on the Lunar surface and resulted in identification of lander and its impact site by NASA. The lander crashed at 70.8810°S, 22.7840°E, 834 m elevation (Source: NASA) shown in Figure 3.

Figure 3 Impact Site of Vikram Lander
(Credit: LRO, NASA)

(Colour Code: Green – Debris ; Blue – Soil Disturbance
S – Debris found by Subramanian)
