HOW NASA DECIDED WEBB WAS READY

INSIDE THE RISK ASSESSMENT

BY JESSE LEITNER AND TUPPER HYDE

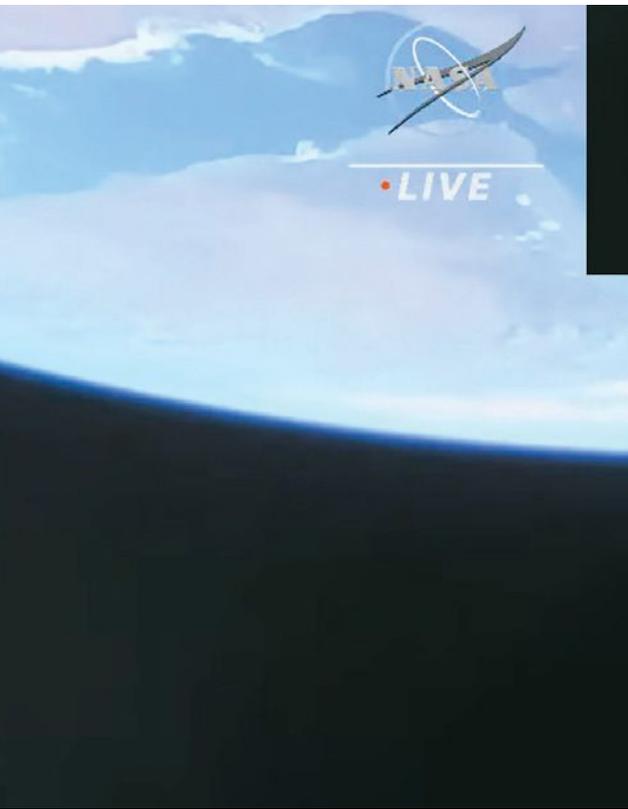
▲ The James Webb Space Telescope was photographed from the Ariane 5 rocket's upper stage shortly after separating in what NASA called "humanity's final look" at the \$10 billion telescope. The black bar at the bottom left is Webb's solar array, which deployed shortly after separation to begin providing power to the spacecraft.

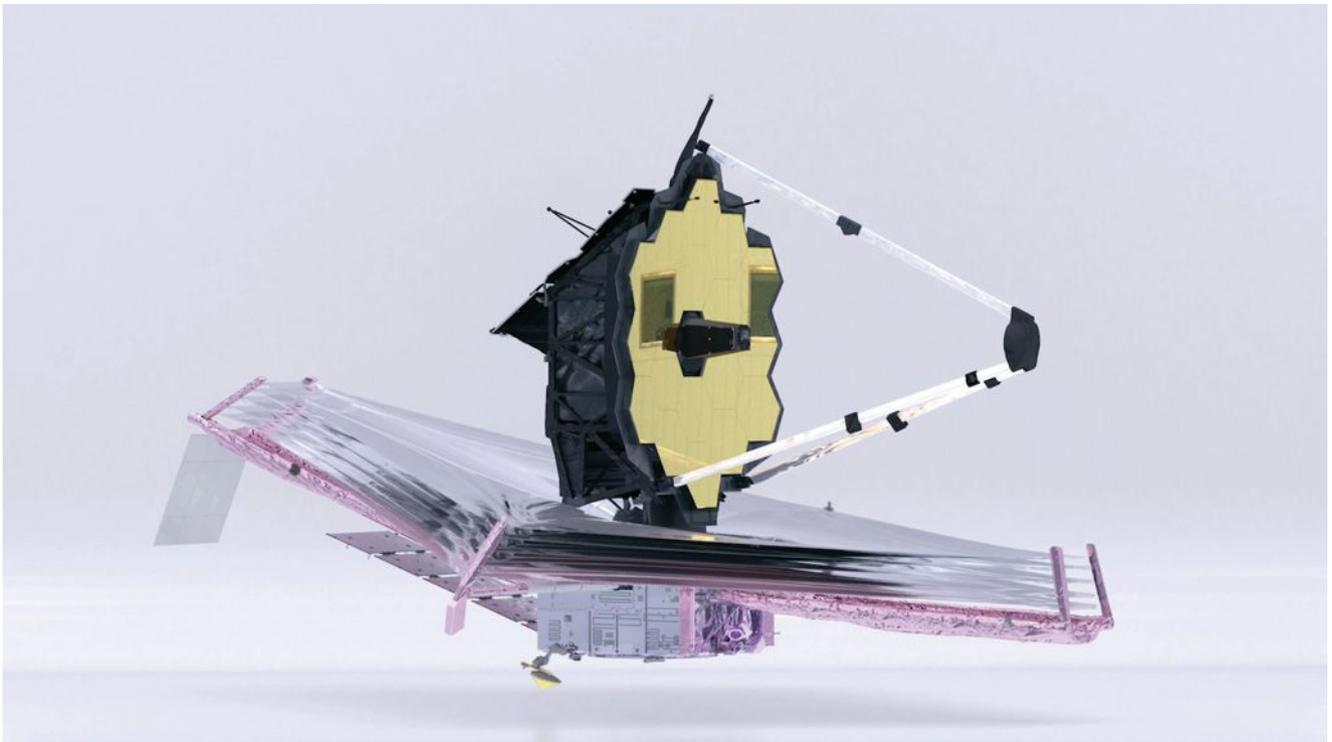
▲ This rendering shows how Webb now looks in space in its fully deployed form. NASA must still align and tune the telescope’s mirror segments, a process that will take several months.
