SCIENTIFIC AMERICAN

November 1986

Engineering Voyager 2's Encounter with Uranus

Difficult problems posed by vast distances, low light levels, aging equipment and mechanical breakdowns were solved by radio control from the ground as the Voyager 2 spacecraft hurtled toward Uranus

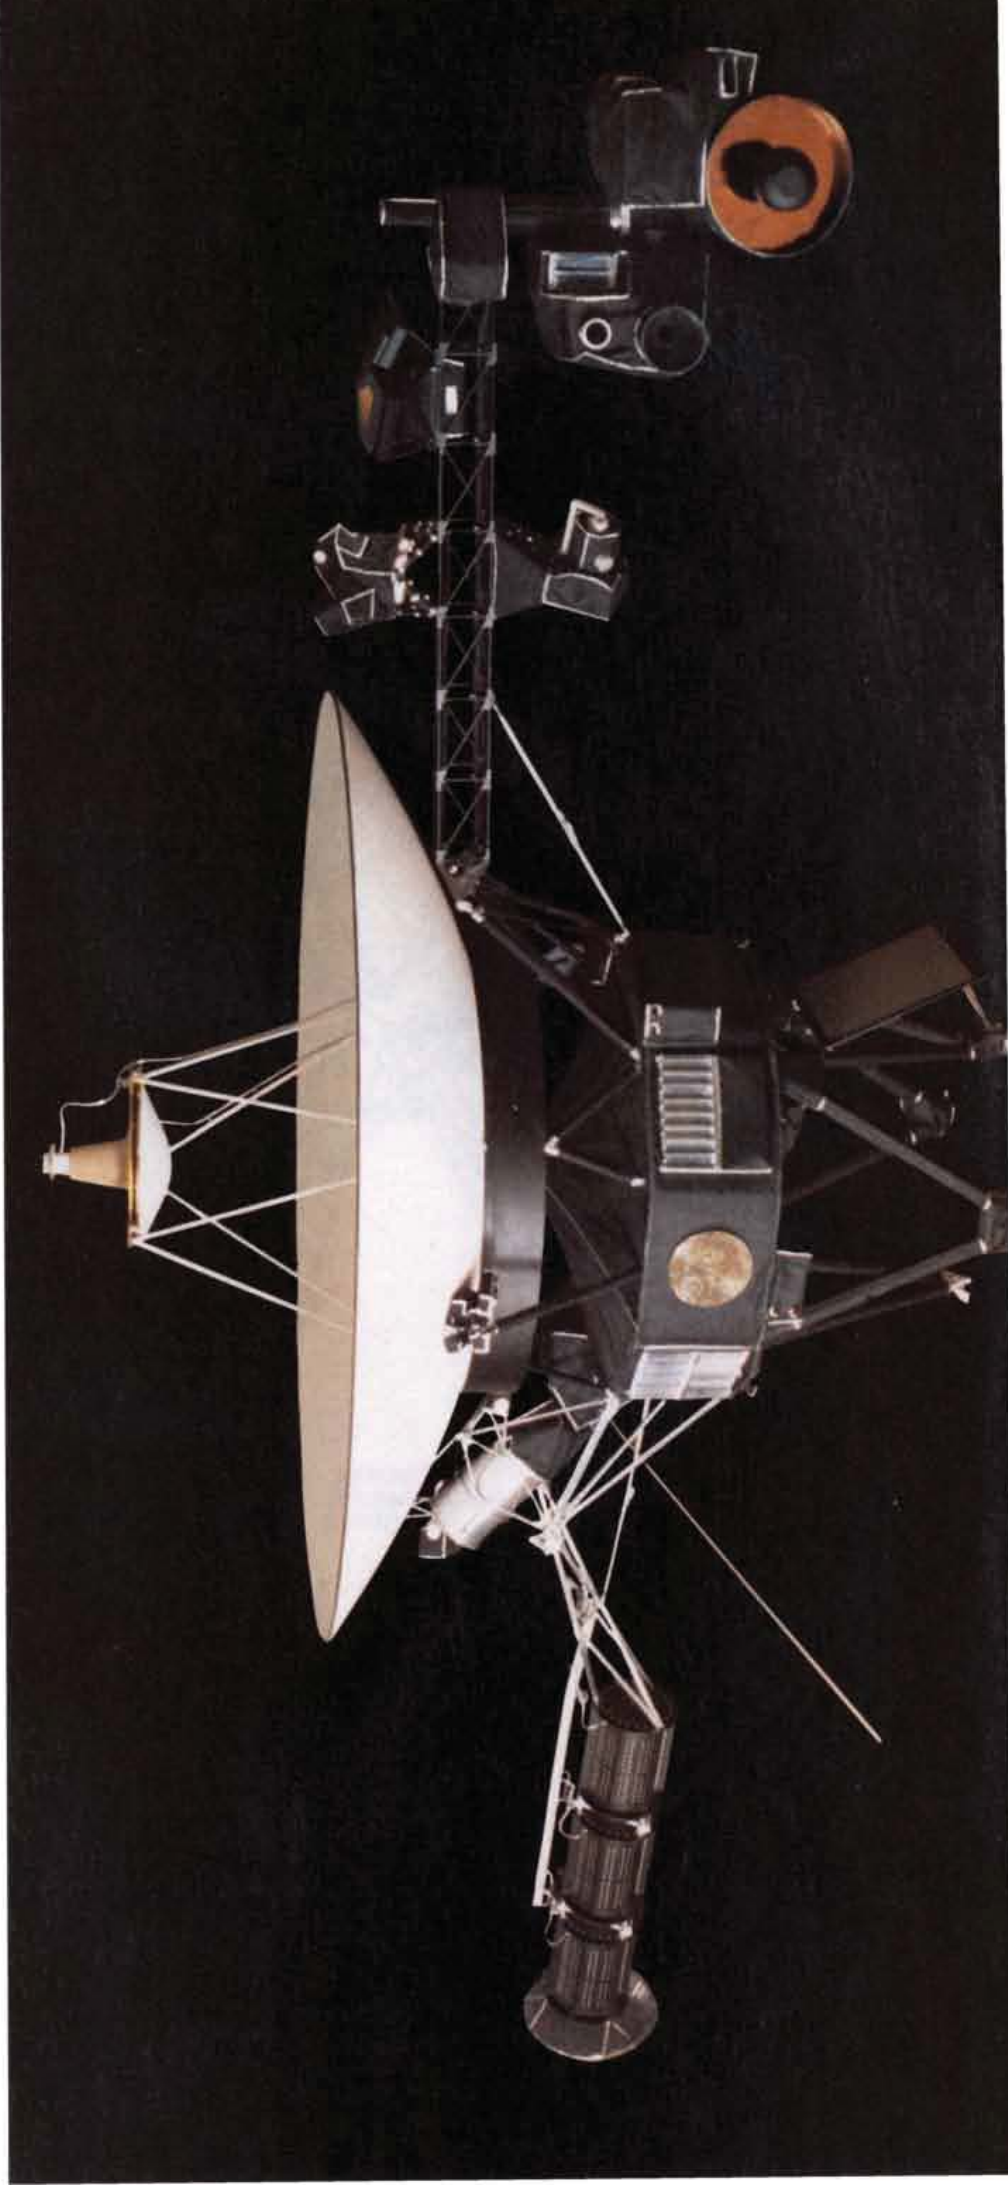
VOYAGER MOCKUP, along with duplicates of the spacecraft's various subsystems, is available at the Jet Propulsion Laboratory for testing new procedures that might be tried on *Voyager 2* as it moves toward Neptune following its successful encounter with Uranus this past January. The mockup differs from the actual spacecraft in that the magnetometer boom (see illustration on next page) is not extended.

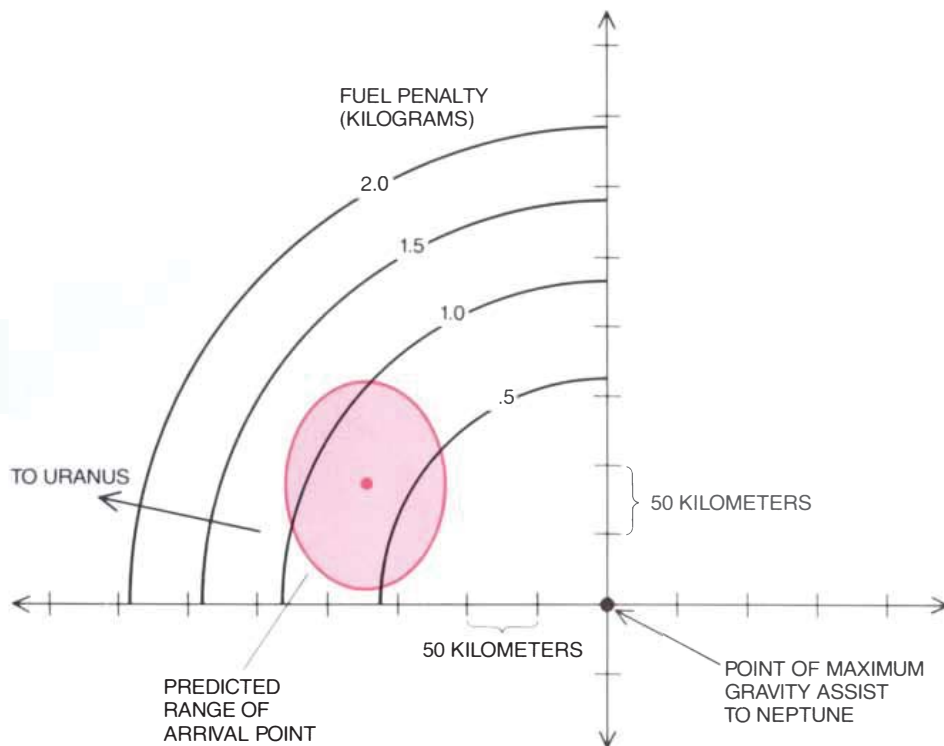
VOYAGER 2'S FUEL CONSUMPTION is minimized by taking full advantage of the gravitational force of large solar-system bodies to deflect the craft toward its targets. The penalty (quarter circles) for not reaching the point where Uranus' gravity would have most assisted it on its journey to Neptune was estimated, five days before the closest approach, to be between one-half and one kilogram of fuel. The project team elected not to perform a trajectory-correction maneuver at that time since the fuel penalty was not costly (62 kilograms of fuel remained in the tank), it would have made tracking the spacecraft more difficult and the team's limited manpower resources could be better applied to other important matters. The coordinate plane is drawn so that it passes through the center of Uranus, some 100,000 kilometers in the direction indicated, and is nearly perpendicular to the direction of travel of *Voyager 2* as it approached the planet. The fuel carried on the spacecraft is hydrazine, a compound of hydrogen and nitrogen. It is stored in liquid form but is converted into a gas before it is expelled through the thrusters.

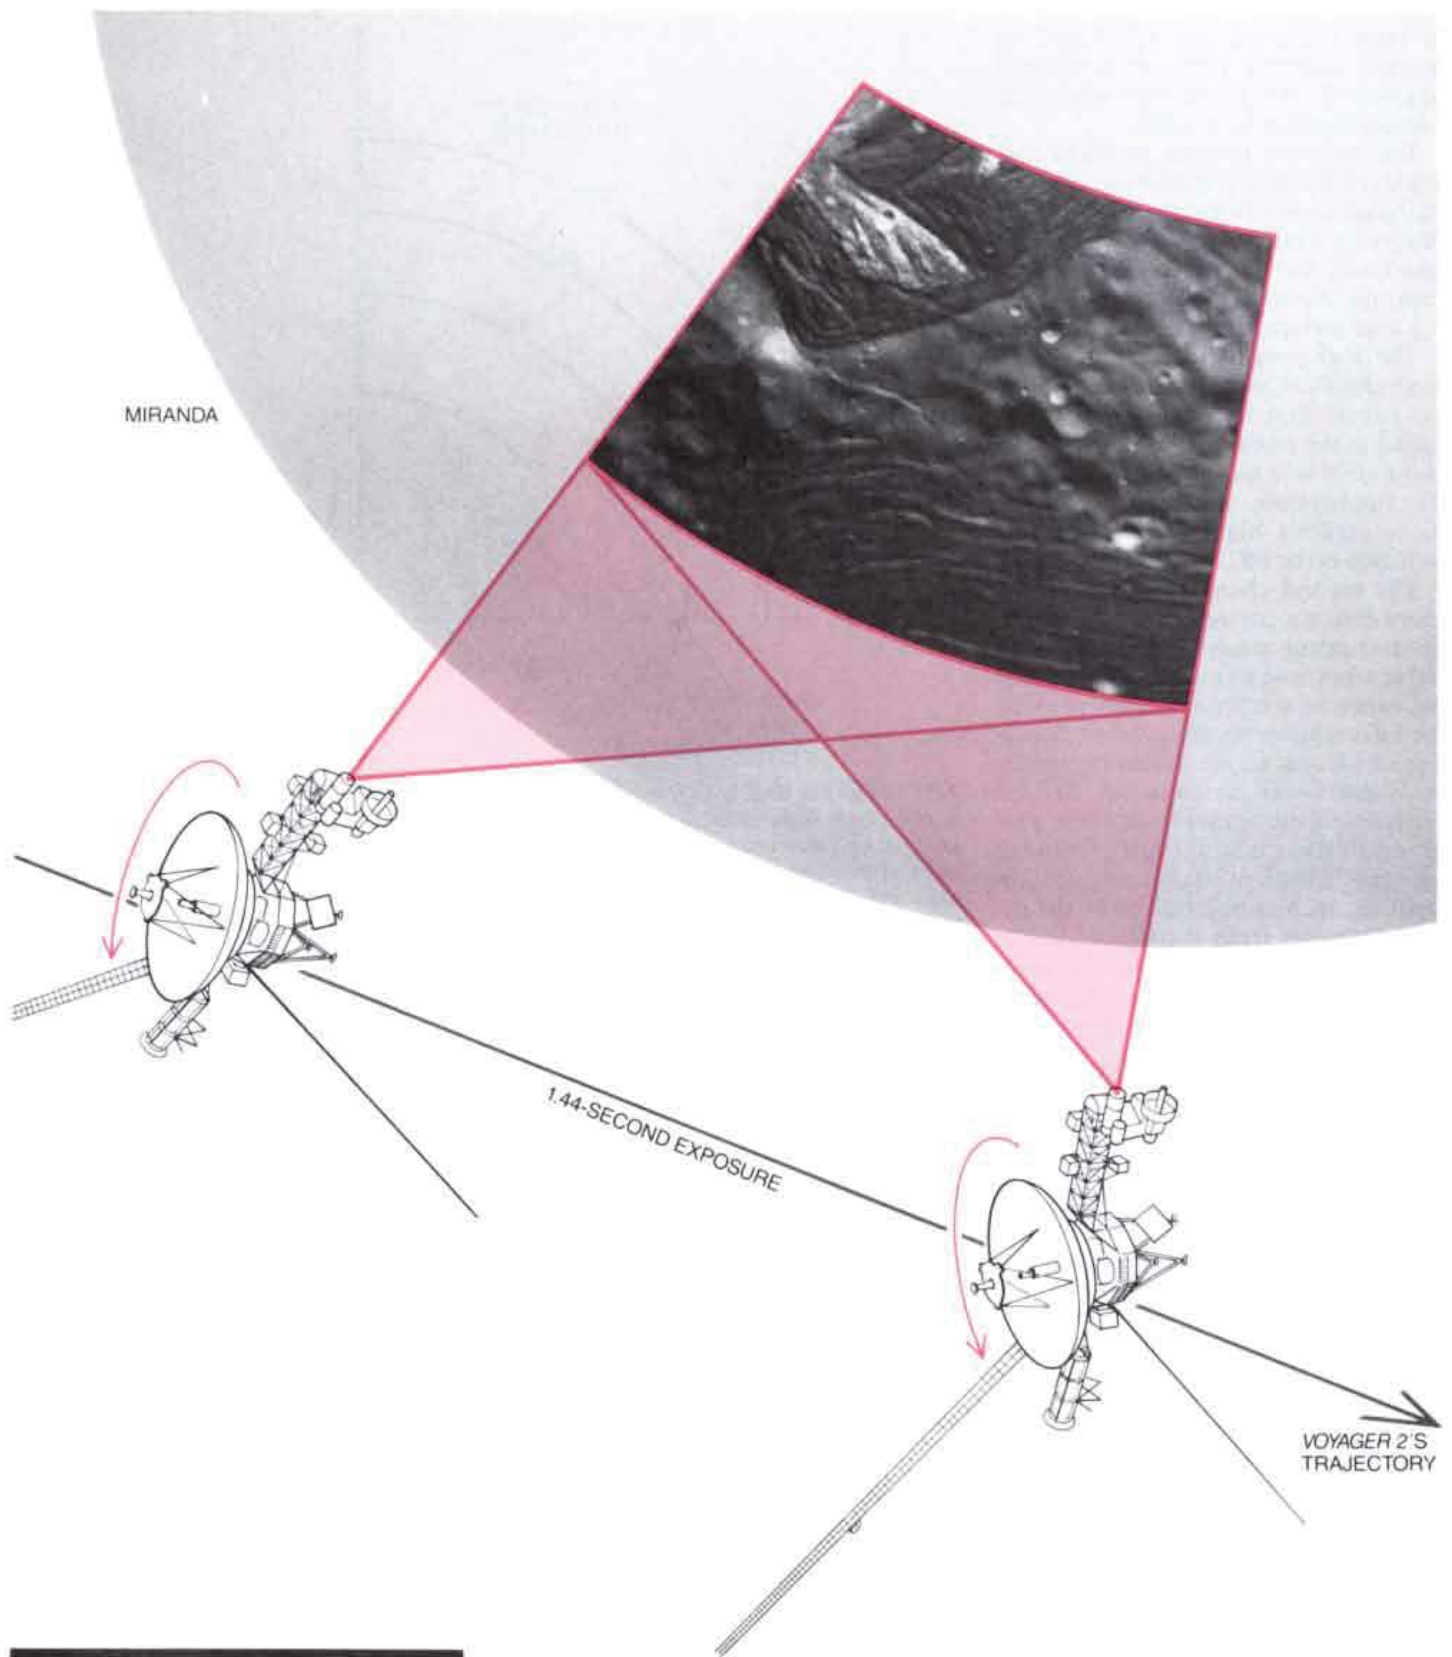
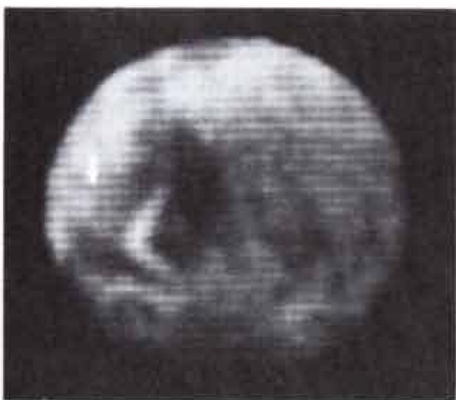
HIGH-RESOLUTION IMAGES OF MIRANDA, one of the moons of Uranus, are among the best images ever made in the course of a planetary flyby. Because of the low levels of sunlight in the vicinity of Uranus, long exposure times were necessary for the various images made during the encounter. To avoid blurred images, the computer logic that operates the firing of the attitude-control thrusters was rewritten to minimize jiggling of the camera while the shutter was open. More important in the case of Miranda was the precise firing of the thrusters to rotate the entire spacecraft smoothly in such a way as to compensate for the relative motion of the spacecraft and its target. During the exposures *Voyager 2* was traveling at 72,000 kilometers per hour as it sped by within 29,000 kilometers of Miranda. The clarity of the images eventually obtained made it possible to resolve surface features as small as half a kilometer. If the spacecraft had not been accurately guided, positioned and rotated, the resolution of the pictures would have been about 26 kilometers, comparable to that of the smaller picture of Miranda on the left, and many of the satellite's topographic characteristics would not have been visible.

The accurate navigation and the motion-compensation maneuver resulted in pictures of Miranda that are among the best images ever returned by a planetary flyby mission. The execution of the power-management procedure during occultation allowed observations to proceed without a hitch, and detailed information on Uranus' atmospheric structure, including temperature and composition, was obtained. The finding that the temperatures at the poles and at the equator were nearly the same was unexpected. During the occultation one 96-second exposure of the back-lighting ring system was successful, and it revealed an intricate dust structure within the system of rings. The magnetometers on the spacecraft revealed another oddity: Uranus' magnetic field. It is tilted 60 degrees from the rotational axis. Hence as Uranus rotates with a period of 17.25 hours (a fact indicated by Voyager data), the entire magnetic field wobbles.

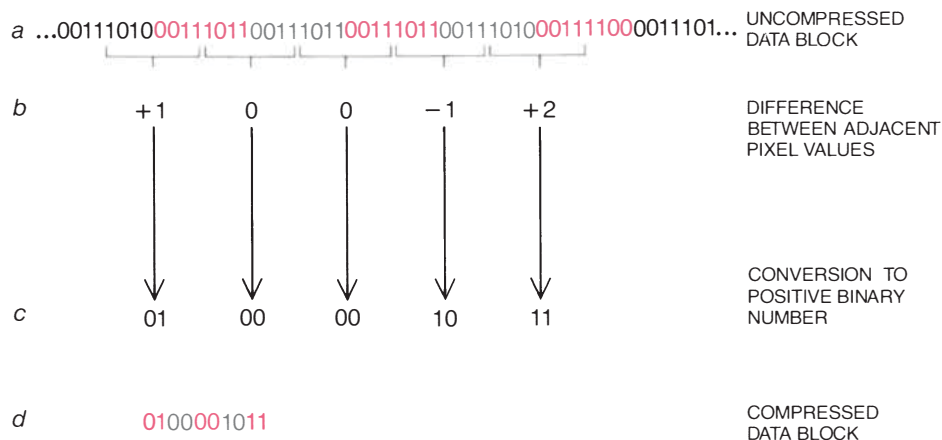
IMAGE-DATA COMPRESSION was applied during the Uranus encounter to reduce the number of bits that had to be transmitted to ground stations. Each line of an image consists of a row of 800 pixels, or picture elements. The brightness of each pixel is expressed as an eight-bit binary number. Rather than transmitting the brightness value for each pixel to the earth, as was done for the earlier Saturn and Jupiter encounters, only the difference in brightness levels between adjacent pixels was transmitted. A simplified version of the technique is illustrated. First the 800 pixels in each row are divided into 160 groups of five pixels each (a). The differences in brightness between the first pixel in a group and the last one in the preceding group and between adjacent pixels within the group are calculated (b). The differences are then converted into positive binary numbers (c). (In this example two-digit numbers suffice.) The final compressed data block transmitted to the earth consists of the five two-digit numbers strung together. In this example data that would have required 40 bits to express are compressed into a block of 10 bits.

The number of bits necessary to express such an image can be more than halved by taking advantage of the fact that adjacent pixels usually have brightness levels that are close in value. This is particularly true for those pixels that do not straddle the borders delineating an object. If *Voyager 2* could be made to transmit only the change in brightness value from pixel to pixel rather than the absolute brightness value for each pixel, then on the average about three bits per pixel would suffice rather than eight. (Obviously the absolute brightness of the first pixel in each row must be transmitted as a starting point.)

This in fact was done. The backup function of the second FDS computer was sacrificed so that the device could be reprogrammed with data-compression algorithms. The image-compression approach is more vulnerable to errors, however, since each pixel-brightness value (except for the first pixel) is dependent on the value of the preceding pixel. Hence a one-bit error could affect an entire row of a compressed image rather than just a single pixel of an uncompressed image. Both compressed and uncompressed modes were therefore applied in the transmission of the almost 6,000 images obtained of the Uranian system.

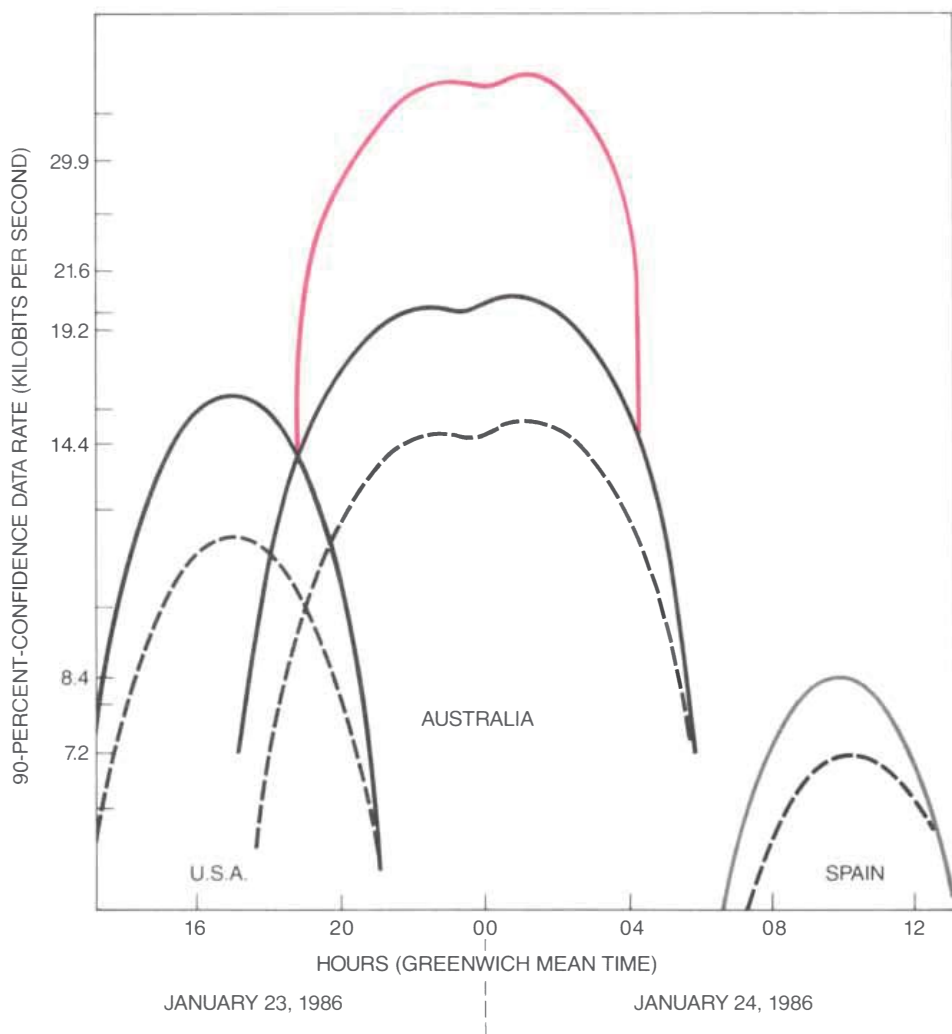
COMMUNICATION CAPABILITY was augmented during the *Voyager 2* Uranus encounter by electronically combining the signals received by an array of antennas. Communication capability is measured in terms of the probability that a given data rate can be received relatively free of error. Shown here are curves representing a 90 percent probability of capturing data from *Voyager 2* as it neared the point of closest approach to Uranus. Various antenna combinations were available at the Deep Space Network complexes of the National Aeronautics and Space Administration in the U.S., Australia and Spain: a 64-meter parabolic-dish antenna alone (broken curves); a 64-meter antenna arrayed with one 34-meter antenna (gray curve), and a 64-meter antenna arrayed with two 34-meter antennas (black curves). By adding the 64-meter Parkes radio telescope in Australia (colored curve) as much as 29.9 kilobits per second could be reliably received. The best reception was achieved in Australia, because Uranus was in the southern sky then.

collection capability of the ground stations was improved by electronically combining the signals received by several antennas on the earth, a procedure called arraying. For example, the 64-meter antenna dish and the two 34-meter dishes of NASA's Deep Space Network tracking complex in Australia were arrayed together and then combined with the 64-meter Parkes radio telescope, which was borrowed from Australian radioastronomers. The rate at which data could be reliably received was increased from 14.4 kilobits per second for a single 64-meter antenna to a potential 29.9 kilobits per second for the array. In practice the highest data rate at Uranus was held to 21.6 kilobits per second; the rate of 29.9 kilobits per second was reserved for emergency situations.
