# EOS

## A Lunar Mission Spots Its Fallen Brethren

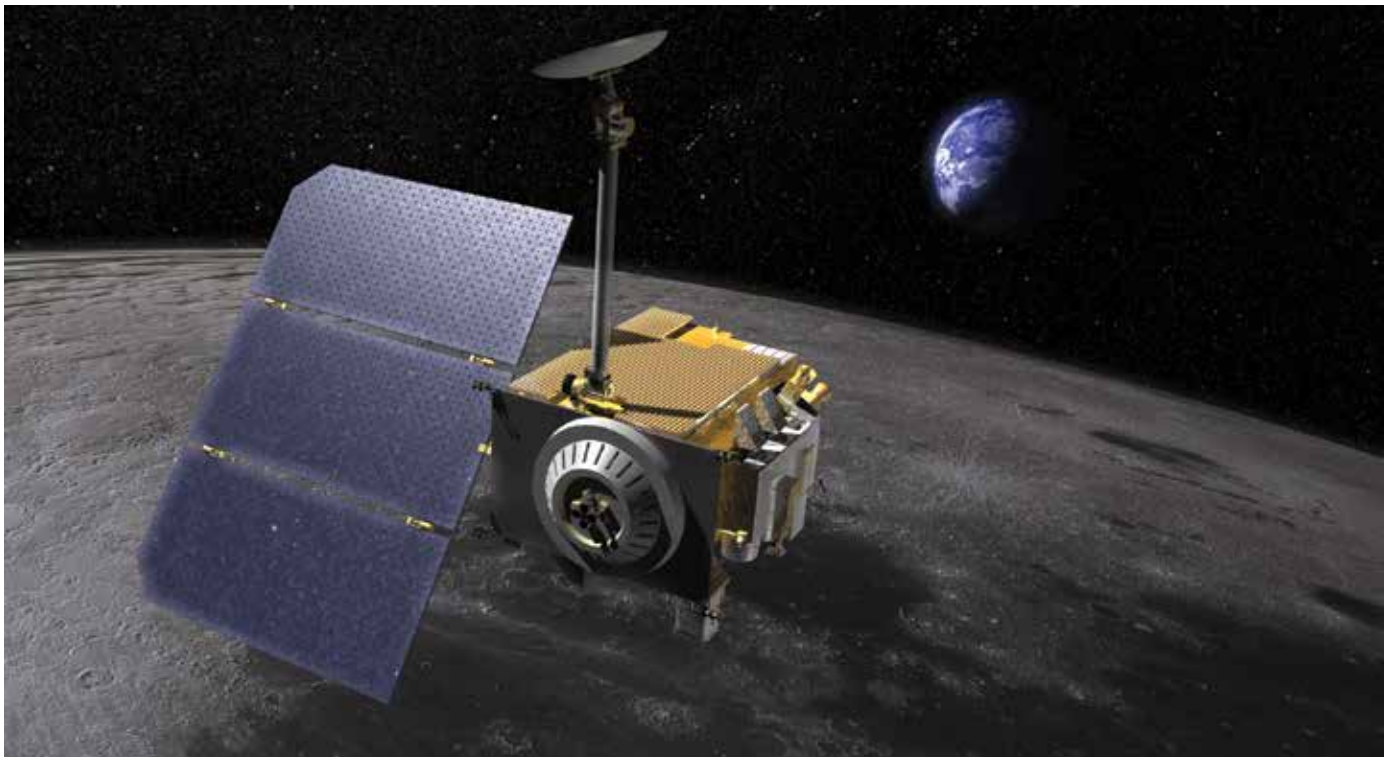
LRO, shown here in an artist’s rendering, has been returning high-resolution images of the Moon’s surface since 2009. Credit: NASA/GSFC

Since 2009, LRO has been returning a treasure trove of data about the Moon's topography, mineralogy, and water resources. The truck-sized orbiter is currently cruising roughly 100 kilometers above the surface of the Moon. The Lunar Reconnaissance Orbiter Camera (LROC)—actually a suite of cameras

consisting of two Narrow Angle Cameras and one Wide Angle Camera—images most of the lunar surface every month.
