History of Rocketry and Astronautics

**Proceedings of the Forty-Sixth History Symposium of
the International Academy of Astronautics**

Can a Pile of Scrap Unmask a New High Technology? The A4/V-2 No. V89 Bäckebo-Torpeden*

Å. Ingemar Skoog[†]

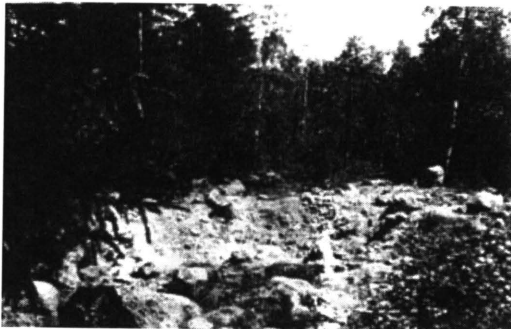
Figure 10-2a: Impact pit from west,
June 1944. Credit: Kjellson, Ref. 9.

The circumstance that some persons close to the impact location heard just one bang and others two is explained by the fact that major rocket parts fell on a very stony ground (Figure 10-2a) and this must have caused a load bang at impact in addition to the explosion in the air. Those persons very close to the impact were, according to own statements, “almost deaf” from the first explosion and could probably not hear the second bang. This confirms that the rocket broke apart at reentry before hitting the ground, which happened to some 30–40 percent of the A4/V-2 rockets at that time [5].

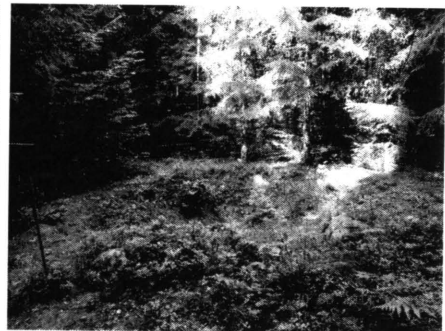
Figure 10-2b: Impact pit from east,
August 2012. Credit: Skoog.

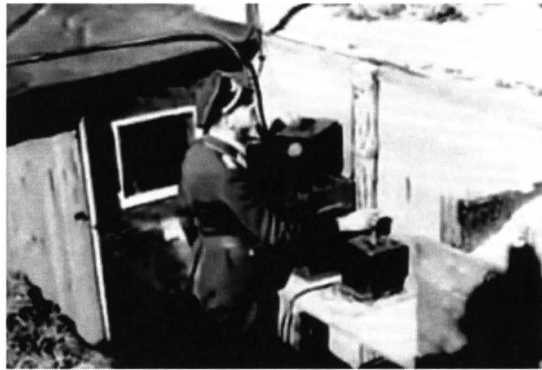
Figure 10–3: Wasserfall joystick guidance system.
Credit: Bundesarchiv / Transit Film.

An A4 test vehicle was prepared for launch at Heersprüfanstalt Peenemünde (HAP) on 13 June 1944. This particular vehicle (V89) was taken out of the regular row of test vehicles for modification of the guidance system. In addition to the two gyros, radio guidance equipment was also installed in the equipment bay directly beneath the war head compartment. The purpose of this additional equipment was to test the guidance system of the Wasserfall anti-aircraft missile also under development at Peenemünde. Wasserfall was guided by sight with a joystick (Figure 10-3). The A4/V-2 No. V89 was for the initial part of the

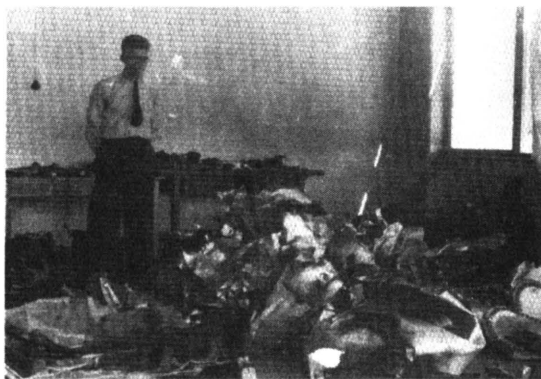
Figure 10–5a: Reconstruction at FFA. Credit: Kjellson, Ref. 9.

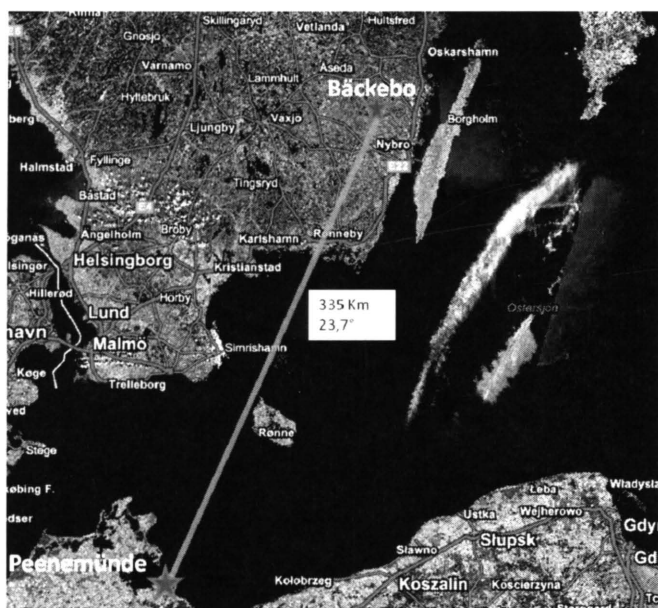
Figure 10–7: Trajectory Peenemünde—Bäckebö, 23°E and 335 kilometers. Credit: Google.

The origin of the rocket was clear right from the beginning. Many parts, in particular pressure vessels, electric boxes and the radio equipment, carried labels with text in German. In the meantime three V-1s had fallen into Sweden, and like the British, the Swedish Air Force flew several reconnaissance missions along the German Baltic coast, which had resulted in knowledge of Peenemünde also in Sweden (Figure 10-6). The launch site was no doubt Peenemünde and thus the range of the rocket was clear, some 335 kilometers (Figure 10-7). In the report, Peenemünde is explicitly mentioned by Kjellson as the place of launch [9, 11].
