# AEROSPACE

# A closer look at Starship's launch pad

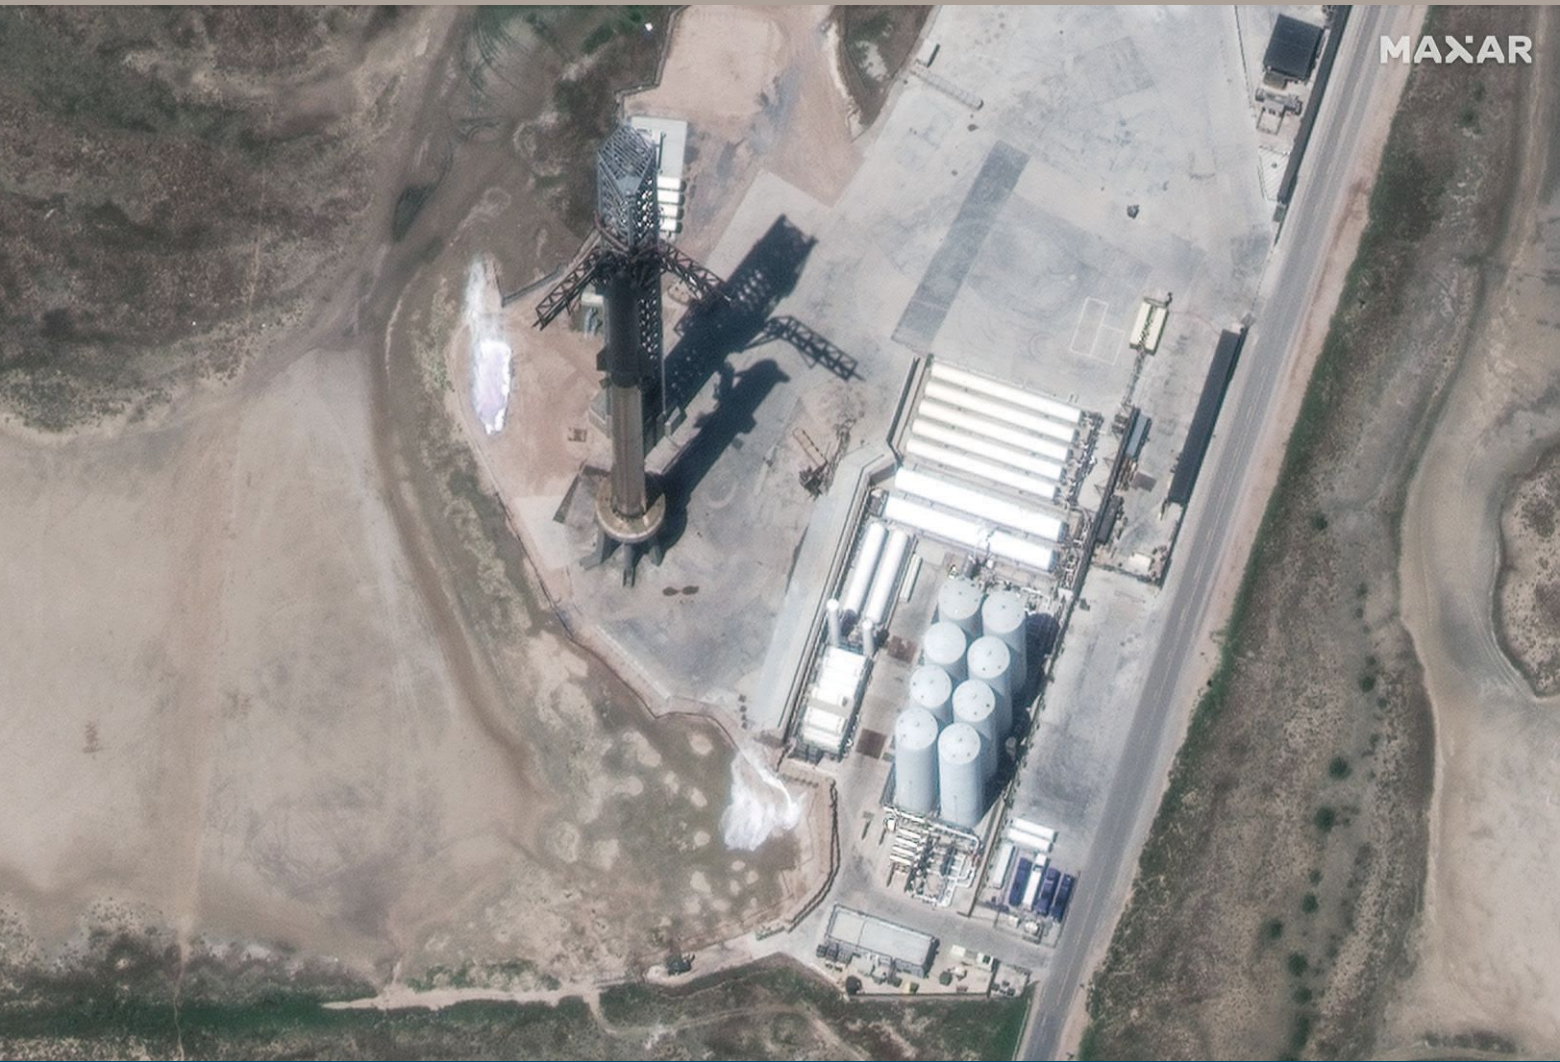
**BEFORE** A Maxar satellite photographed the Starship rocket prior to its April 20 launch from Boca Chica, Texas. [Maxar Technologies](#)

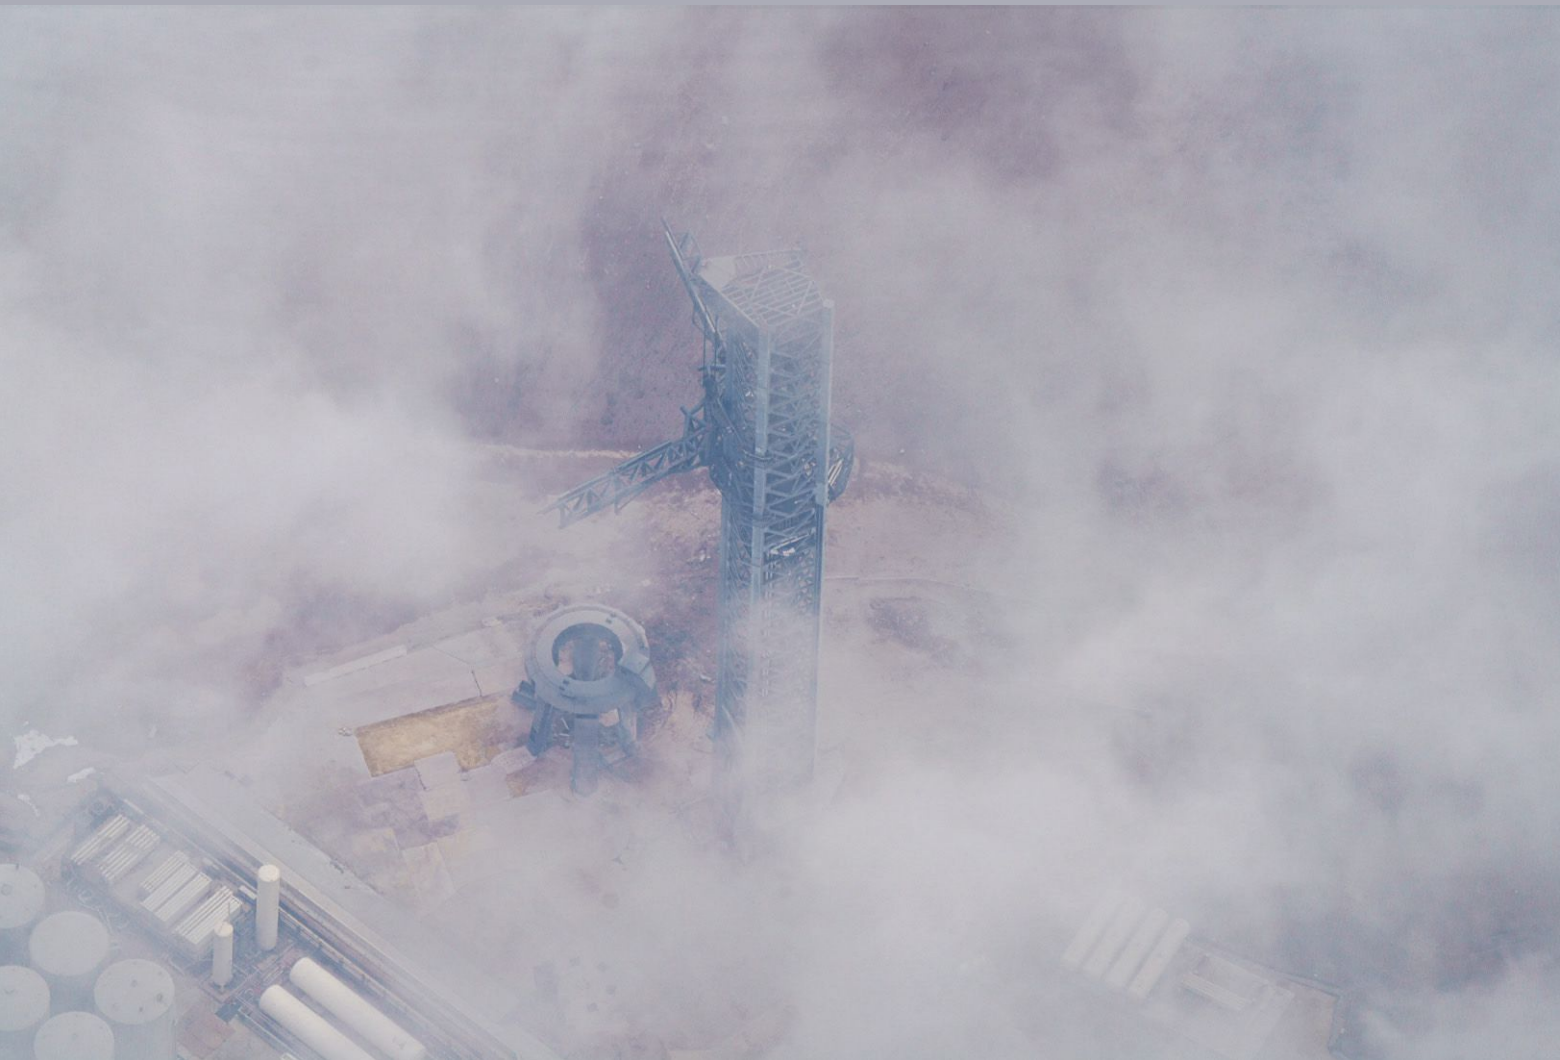
**AFTER** Chunks of the concrete launch pad were blown away, exposing the ground beneath, as seen in this drone photo. *RGV Aerial Photography*

Philip Metzger, a planetary scientist at the University of Central Florida, has been looking into the aftermath of the destruction of the concrete launch

pad, caused when the rocket's 33 first-stage engines ignited to generate 64 meganewtons of thrust. That's nearly twice the power of the Space Launch System rocket that NASA launched in November.

Studying imagery and videos, he found that some pieces of debris were so large that they caused a six-story-high splash when they fell into the nearby Gulf of Mexico, while sand from the ground was recorded

“five or six miles from the launch pad,” he says.

The U.S. Fish and Wildlife Service said in a statement that “impacts from the launch include numerous large concrete chunks, stainless steel sheets, metal and other objects hurled thousands of feet away along with a plume cloud of pulverized concrete that deposited material up to 6.5 miles [10.5 kilometers] northwest of the pad site.”

The staff found debris scattered over an area of 1.5 million square meters, and noted that a 14,000-square-meter fire started at Boca Chica State Park.
